Building Inspection Report

----- **Essex, VT**

Inspection Date:
11/05/2011

Report Number:
4539.1111

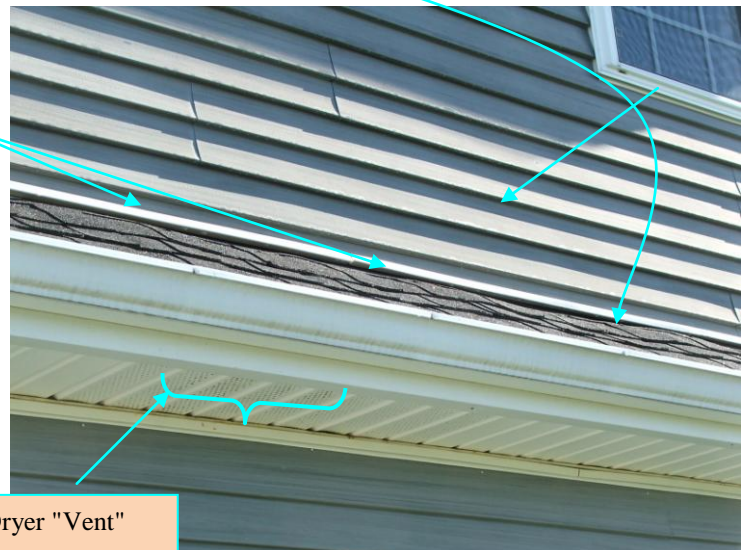
- **Repair:** Rippled areas were noted on the rear return roof. This is suspected to be from warped sheathing. This, in turn is likely from the dryer venting into the return. Moisture damage could be present. recommend further investigation and any repairs deemed necessary. See also **Flashings** – below; **Dryer** - page 26 and **Exterior Eaves** - page 11

- **Repair:** The roof/wall flashing along the west return section is damaged and should be repaired to avoid leaks.
- **Monitor:** The installation of the roof/wall flashing is less than ideal. Step flashing does not appear to be present. This can cause damage to go unnoticed. Recommend professional repairs if needed.
- **Repair:** The roof/wall (step) flashing, at the front slope could leak or ‘dribble’ at the bottom of the roof/wall detail. It could be adjusted to include a ‘kick out’ flashing. A qualified experienced carpenter or roofing contractor should perform this work.

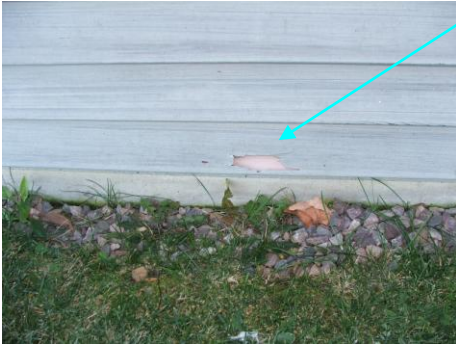
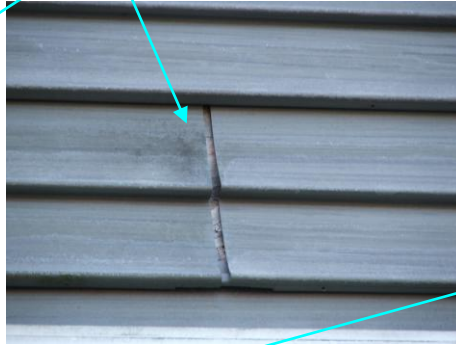
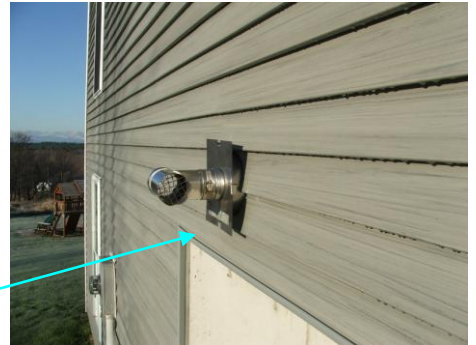
- **Improve:** Damaged/cracked and loose siding in a few locations should be repaired or replaced. A qualified experienced carpenter should perform this work.

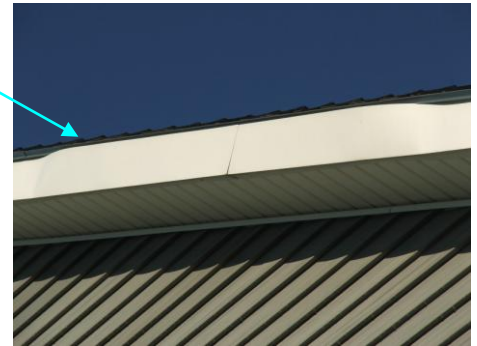
- **Repair:** The fascia (trim around the roofline) is loose at the south slope. It should be repaired to prevent wind damage and leaks. A qualified carpenter or siding contractor should perform this work.
- **Possible Safety Issue:** A partially blocked dryer exhaust arrangement was observed at the rear soffit/return. It should be vented to the building exterior. Blocked exhaust vents can be a fire risk. See also **Sloped Roofing and Flashing** - page 9

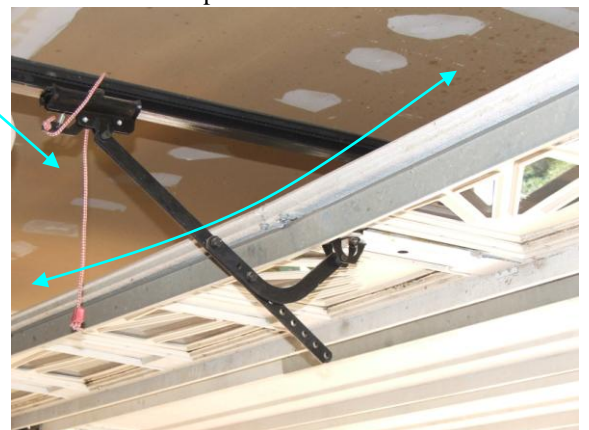
- **Safety Issue:** The overhead garage door is damaged and needs to be repaired or replaced. It could malfunction or even fall in its present condition. A qualified experienced overhead door contractor should perform this work.
- **Safety Issue:** The garage door opener did not automatically reverse under mechanical resistance to closing. A qualified overhead garage door technician should adjust it. See also Positive Observations above – *The infrared light...*
- **Monitor:** The slope of the garage floor is not conducive to good drainage. The slab appears to have settled. Improvement is not a priority but you should be aware improper slope risks sending water towards the building interior. Puddles can occur which can freeze.

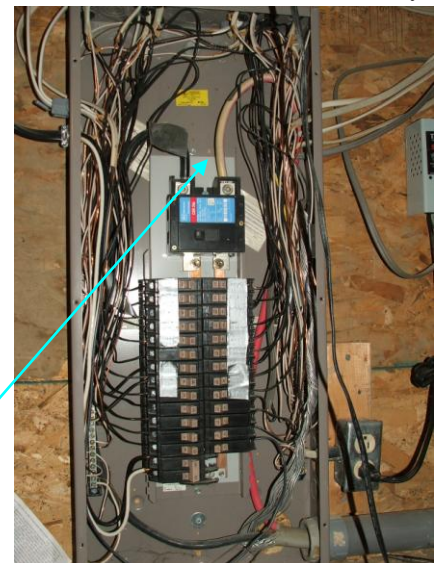
- **Monitor: Possible Safety Issue:** One of the main feeds is highly discolored. Overheated wiring within the main distribution panel should be examined by a licensed electrician and repaired as necessary.

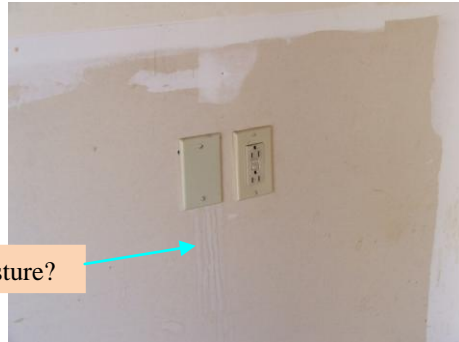
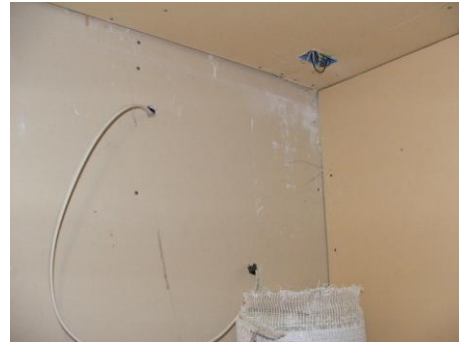
- **Safety Issue:** Unfinished wiring in the basement bathroom should be made temporarily safe from shock hazard until complete.

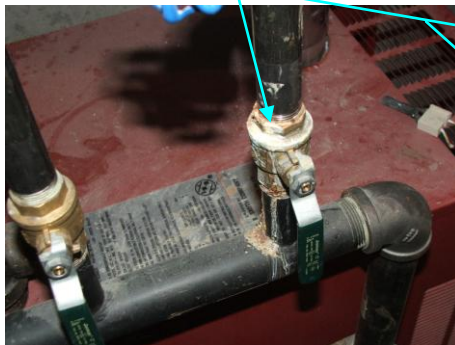
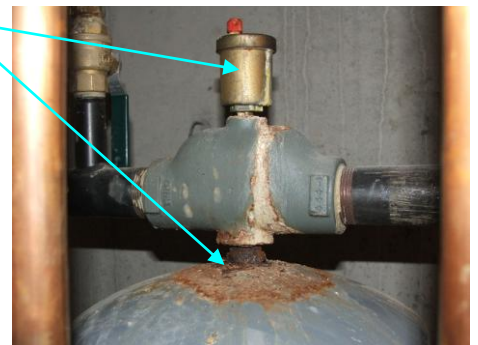
- **Repair, Safety Issue:** There is evidence of a gas leak in the vicinity of the boiler. *This is a serious safety concern. It is recommended that the gas utility be engaged immediately. The current occupants of the home should be notified.*
- **Repair:** Sloppy wire connections at the boiler should be improved. A qualified licensed heating technician or licensed electrician should perform this work.
- **Repair:** A serious amount of corrosion was observed on and above the expansion tank and on the air vent. Damages like this at heating equipment should be repaired promptly to avoid equipment failure and to assure reliable system operation. A qualified licensed heating technician should perform this work.
- **Monitor:** The boiler shows evidence of prior leakage at a circulation pump. Watch for and repair any leaks promptly as prolonged leakage can damage the boiler.

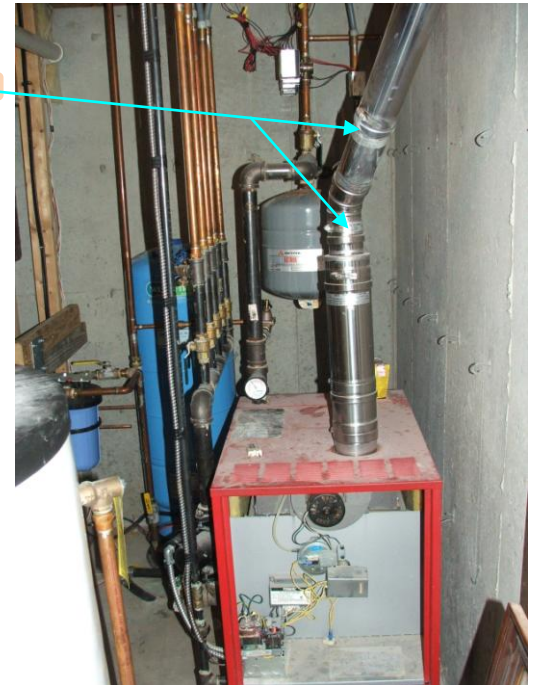
- **Safety Issue:** The exhaust vent clamps may employ gaskets that are known to deteriorate. The flue connection is somewhat loose. This condition should be evaluated by a qualified licensed heating technician right away..

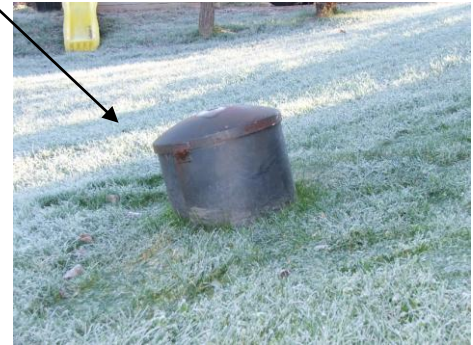
- **Repair:** The exterior hood of the propane gas tank is leaning badly. It could interfere with piping under this condition and cause a gas leak. The gas company should correct this right away.
- **Monitor:** Be mindful of the soft copper gas line leading from the tank to the home when digging, gardening etc.
- **Monitor:** A shut off valve could not be seen behind the dryer. The gas technician should install one if needed.

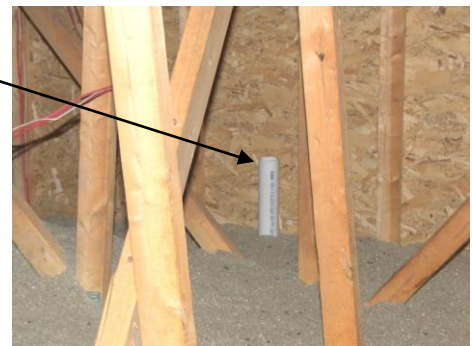
- **Repair:** Although all drains operated freely and no ‘suspicious’ areas were seen, heard or smelled outside, it is recommend the septic tank be cleaned and serviced by a qualified technician.
- **Repair:** The vent stack that penetrates to the attic should extend at least 12 inches above the roof and should be at least 2 inches in diameter.

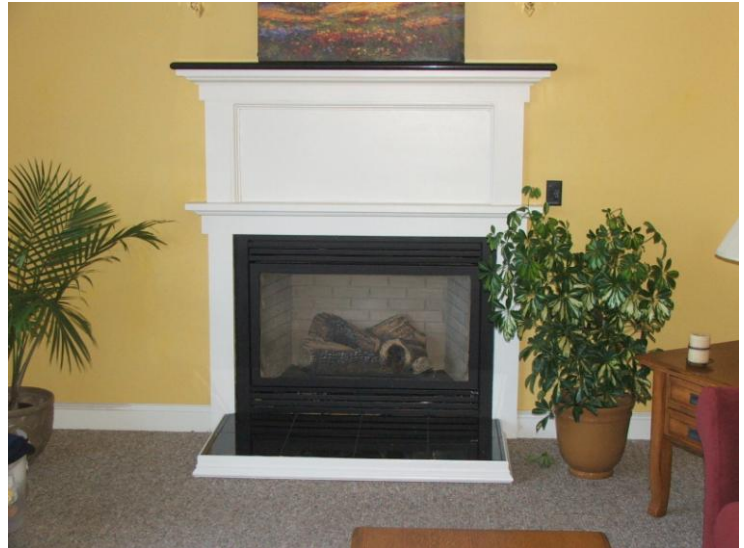
- **Safety Issue:** The glass of the fireplace will get too hot to touch. Carelessness here will result in a serious burn. Recommend providing a screen for this area. Families with children should be especially aware of this.
